**FRENCH RIVER BASIN
DUDLEY, MASSACHUSETTS**

**PETER POND DAM
MA 00112**

PHASE I INSPECTION REPORT NATIONAL DAM INSPECTION PROGRAM

AUGUST, 1978

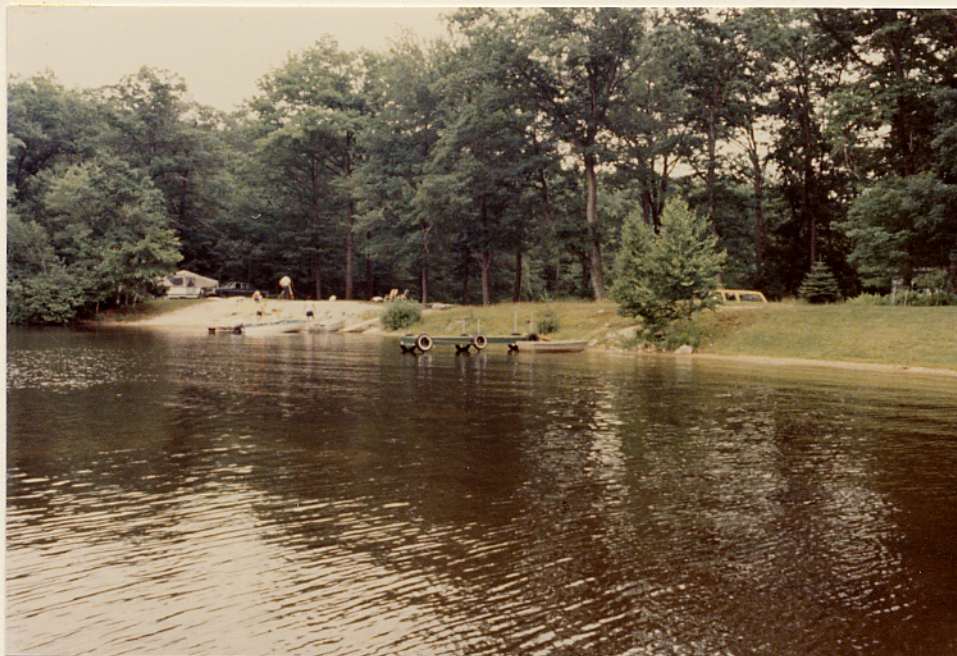
VIEW OF UPSTREAM FACE OF DAM

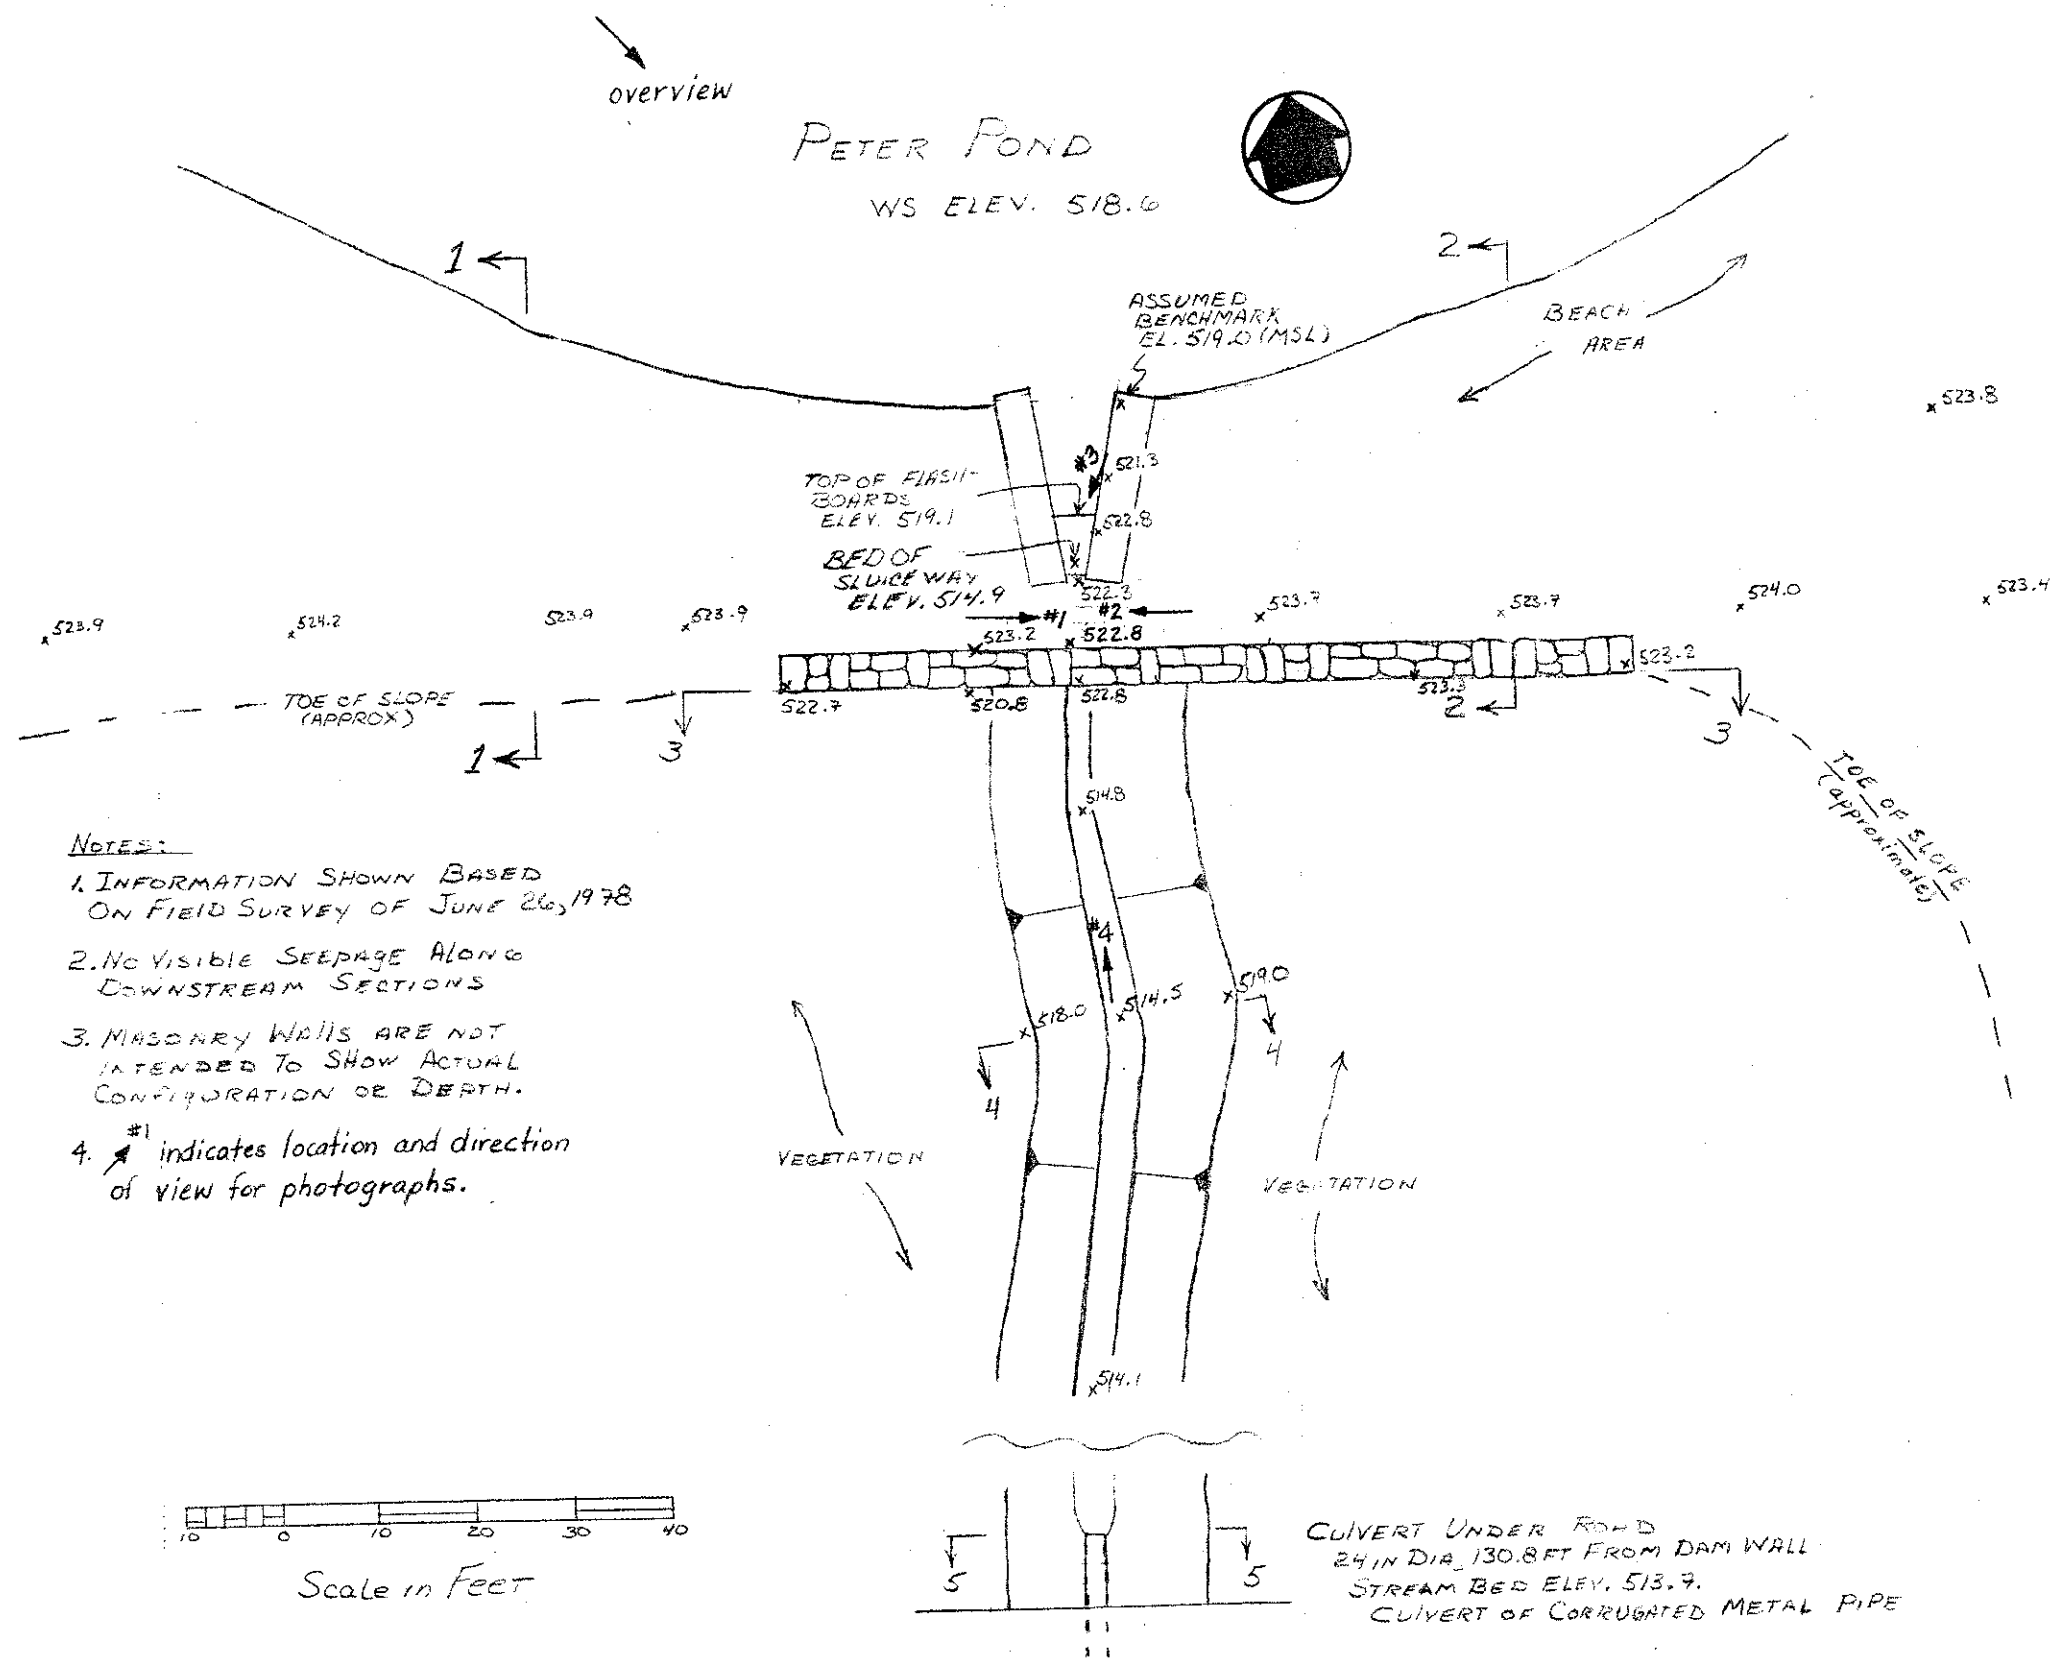
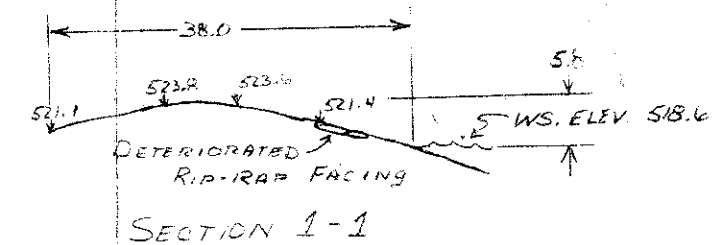
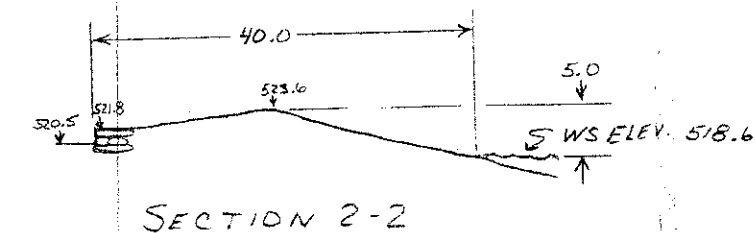
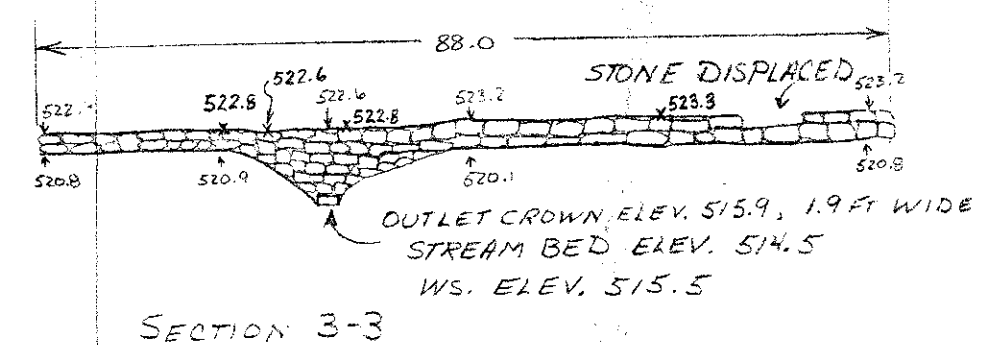
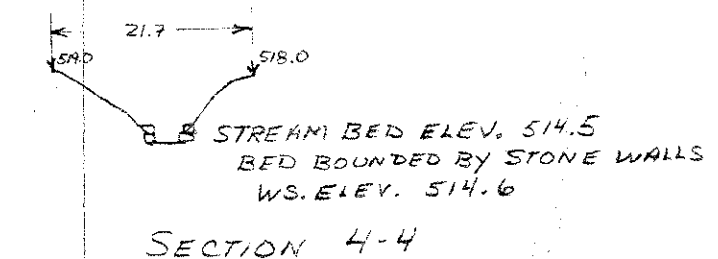
FIGURE B-1 PLAN OF DAM AND SECTIONS

- a. Location. The dam is located in the Town of Dudley, Worcester County, Massachusetts, on a tributary of the French River.
- b. Description of Dam and Appurtenances. Peter Pond Dam is an earthfill dam with a vertical masonry wall on the downstream face. The embankment is 225 feet long and 10 feet high. The stone masonry wall is 88 feet long, 2 to 8 feet high, and about 3.5 feet thick. Discharge from the pond flows over flashboards near the center of the dam and through a stone box conduit with the outlet at the downstream stone masonry wall (see Figure B-1 in Appendix B).

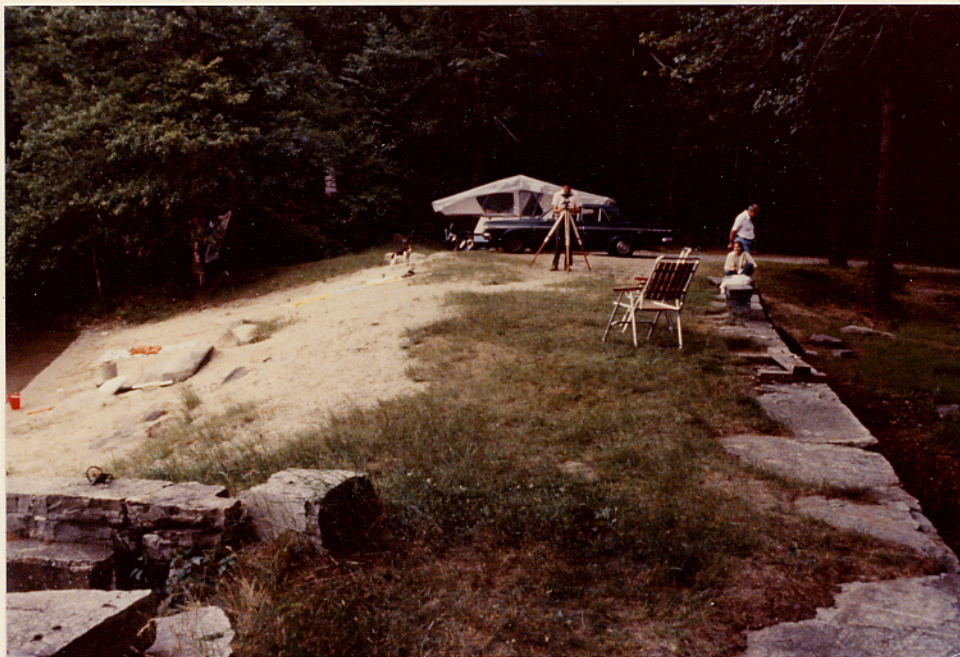
NO. 1 - VIEW EAST FROM SLUICEWAY

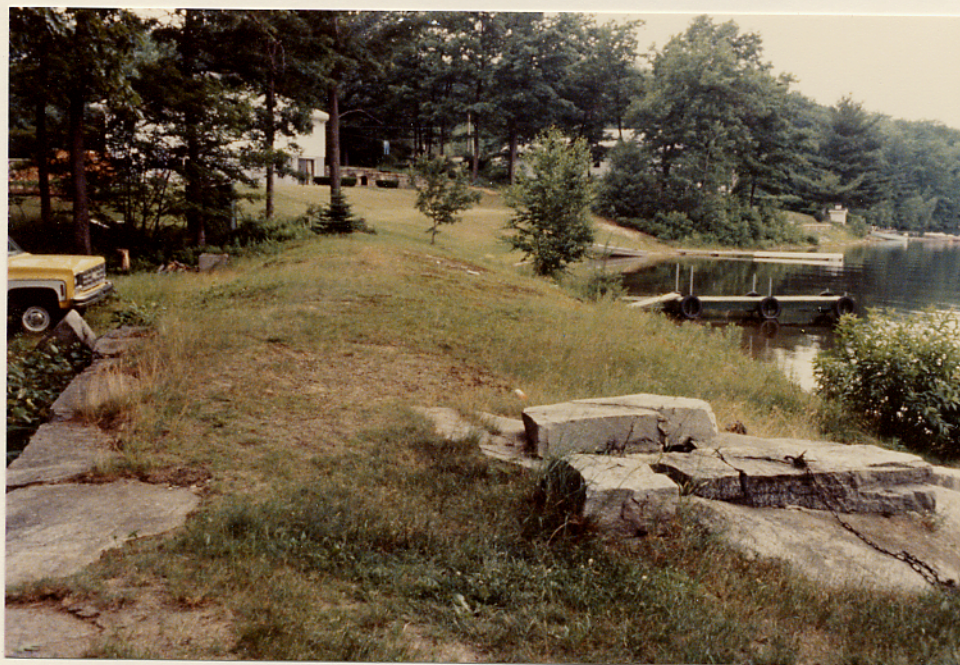
NO. 2 - VIEW WEST FROM SLUICEWAY

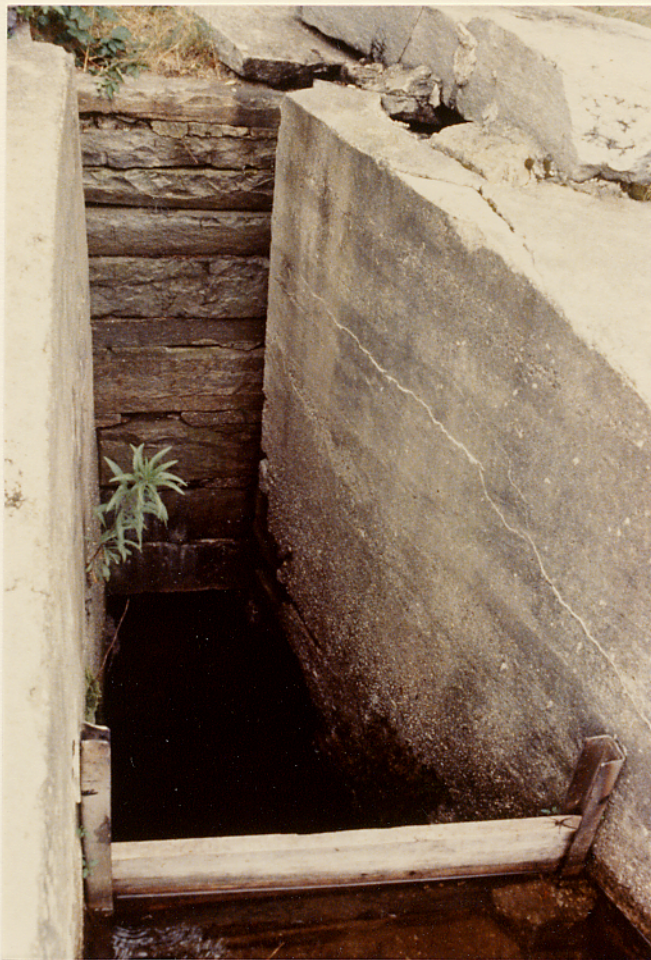
The downstream dry-masonry stone wall appeared in sound condition. Several large stones were missing near the eastern end.
- c. Appurtenant Structures. The outlet appears to be in satisfactory condition although siltation of the approach channel was noted. Flashboards had been added above a timber crib wall. Flow over the flashboards is immediately discharged through a 1.0 foot high by 1.9 feet wide outlet conduit and into a natural downstream channel.
- d. Reservoir Area. There are a few residences in the vicinity of Peter Pond Dam. The drainage area is primarily woodland and swamp.
- e. Downstream Channel. The channel is kept reasonably free of vegetation and debris. The channel side slopes are covered with brush and small trees.

**NO. 3 - VIEW OF SLUICEWAY WITH WOODEN
FLASHBOARDS IN FOREGROUND**

- (1) construct an overflow spillway which could handle all of the required outflow without overtopping the dam,
 - (2) repair the headwall above the outlet conduit where water flows out during the spring,

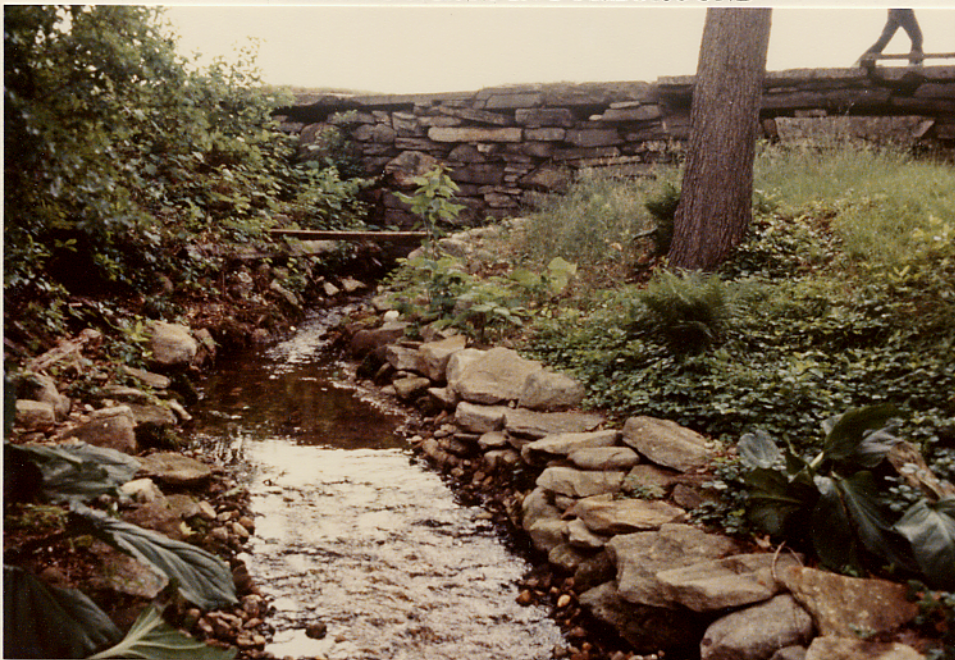
**NO. 4 - VIEW OF DOWNSTREAM CHANNEL
LOOKING TOWARD DAM**
